# **INDOOR AIR QUALITY ASSESSMENT**

**Lincoln-Hancock Elementary School  
300 Granite Street  
Quincy, Massachusetts**

Prepared by:  
Massachusetts Department of Public Health  
Bureau of Environmental Health  
Indoor Air Quality Program  
June 2017

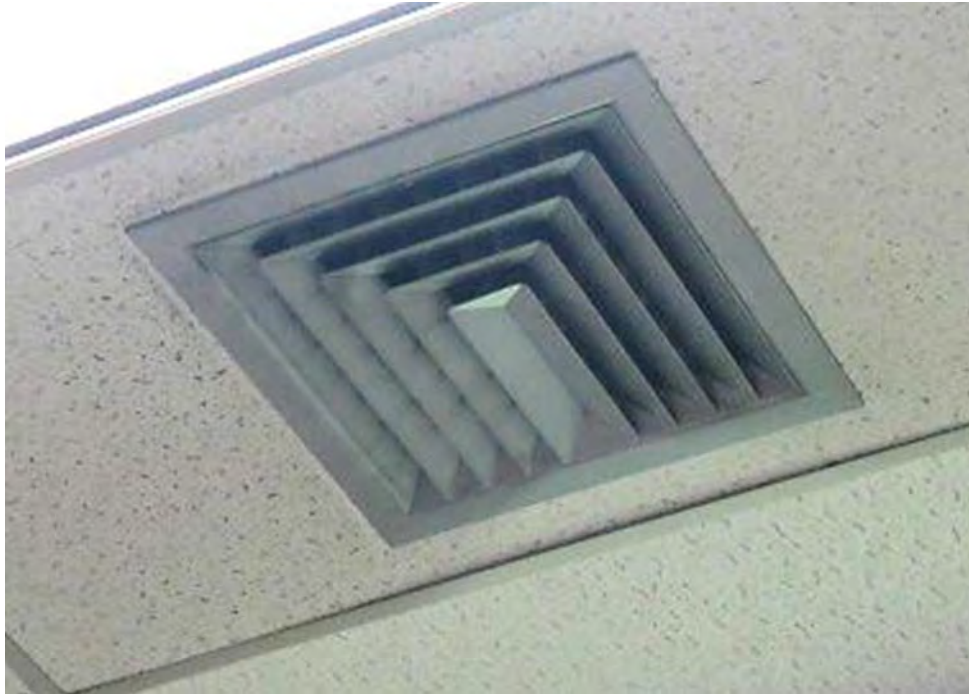
**Picture 1**

Testing results suggest that sufficient fresh air was being introduced into the space at the time of assessment. Outside air is brought in via an air handling unit (AHU) and delivered to classrooms via ceiling-mounted supply diffusers (Picture 1). Air is exhausted from ceiling-mounted exhaust vents on the opposite side of the room (Picture 2). Exhaust vents are located near classroom doors. Note that when classroom doors are open, exhaust vents will tend to pull hallway air *into* the classroom instead of removing stale air/pollutants *from* the room and out the building.

**Supply vent**

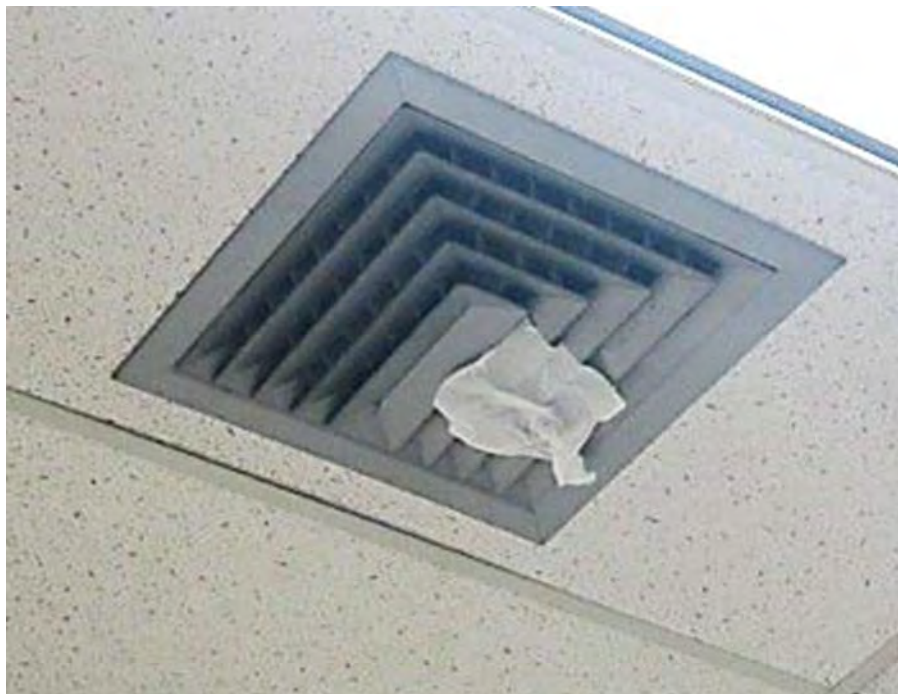
**Picture 2**

**Exhaust/return vent, tissue shows air draw into vent/out of classroom**

7. Close classroom doors to maximize air exchange/improve exhaust capabilities.
8. For buildings in New England, periods of low relative humidity during the winter are often unavoidable. Therefore, scrupulous cleaning practices should be adopted to minimize common indoor air contaminants whose irritant effects can be enhanced when the relative humidity is low. To control for dusts, a high efficiency particulate arrestance (HEPA) filter-equipped vacuum cleaner in conjunction with wet wiping of all surfaces is recommended. Avoid the use of feather dusters. Drinking water during the day can help ease some symptoms associated with a dry environment (throat and sinus irritation).

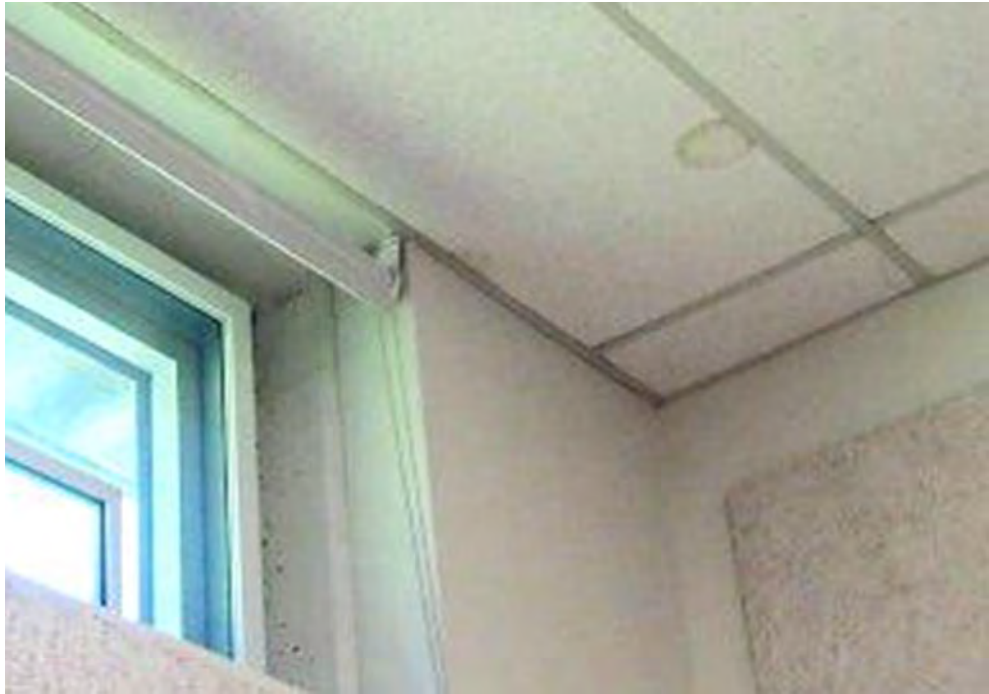
**Picture 3**

In order for building materials to support mold growth, a source of water exposure is necessary. It was reported that the area (room 106) experiences periodic leaks from the exterior during heavy wind-driven rain, particularly behind a large bookcase in the left/front corner of the

classroom. It was also reported that numerous attempts have been made to make repairs/water-proof the exterior in this area to prevent further leaking. At the time of assessment, the area was dry and no visible mold growth was observed on building materials. Small stains were observed on a ceiling tile (Picture 3) in the corner of the classroom, which is evidence of leakage and should be changed after a leak is identified/repared. Adjacent rooms 104 and 109 also contained a few water-damaged ceiling tiles.

**Stained ceiling tile in room 106**

1. Work with HVAC technician/school maintenance personnel and school staff to investigate/improve excessive heat conditions in room 106 (and other areas of complaints) to improve comfort.
2. Continue to work to identify/repair potential sources of leaks from the building envelope.
3. Relocate bookcase in classroom 106 away from area of reported leaks.
4. Remove/relocate all paper/porous items stored in known areas of leaks. If water-damaged/moldy, discard.
5. For more information about mold/remediation consult "Mold Remediation in Schools and Commercial Buildings" published by the US Environmental Protection Agency (US EPA, 2008).
6. Use openable windows in conjunction with mechanical ventilation to increase air exchange. Care should be taken to ensure windows are properly closed at night and weekends to avoid the freezing of pipes and potential flooding.
